Case Report Series

Successful Rehabilitation of a Fractured Molar Tooth with NEVO

Referred patient for implant placement of missing tooth 27

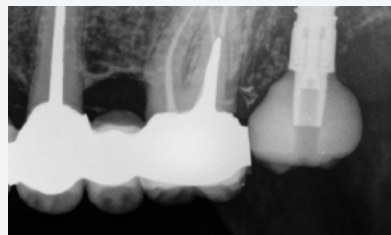
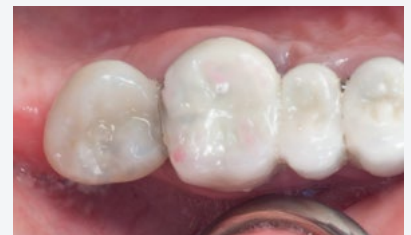
With just three appointments, the case was successfully completed. Radiographs confirmed stable bone levels, the soft tissue appeared healthy, and the patient was very satisfied with the result
