Dr. Nicolas Frydman,  
France

#### Mesial infiltration and crack in first lower right molar

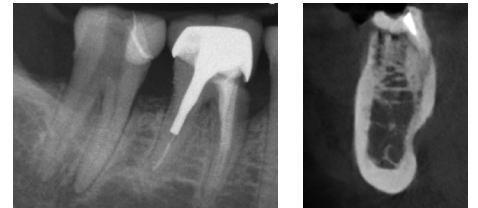
A 44-year-old female heavy smoker presented with mesial infiltration under an old crown and a vertical crack in the first lower right molar. The crown was a monolithic PFM with a post on the distal root. CBCT confirmed buccal bone wall integrity and 17 mm bone height.

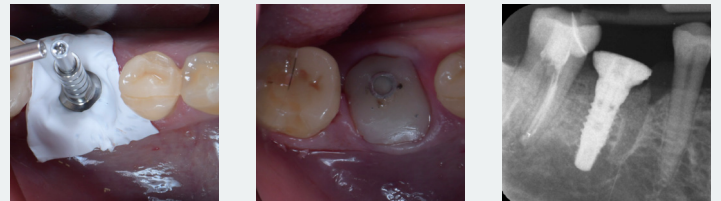
### 2 Socket seal abutment

- Immediately after implantation, placement of Teflon film between the used VARIO-temp abutment and the implant to prevent chemical contamination of graft material and blood clot
- Shaping of anatomic abutment using flowable composite
- Use of this socket seal abutment to keep graft material in place and avoid shrinkage after bundle bone loss

- Root separation and careful extraction
- Gentle osteotomy between septum and distal root
- Placement of an ELEMENT RC implant (PF 5.0, L 11 mm) with a torque of + 45 Ncm
- Careful implant positioning to ensure screw emerged in occlusal area of future crown, enabling a screw-retained crown
- Stabilization of blood clot by filling root gap with small-particle bovine xenograft

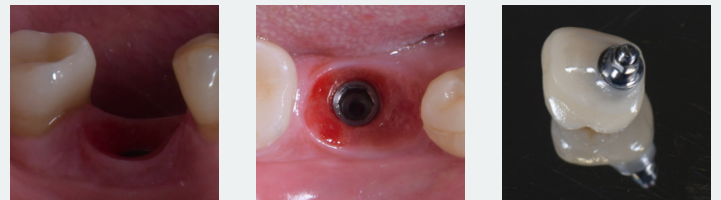
### 3 Crown placement

- Good soft tissue height and volume compared with baseline observed after 12 weeks
- Placement of screw-retained full zirconia crown

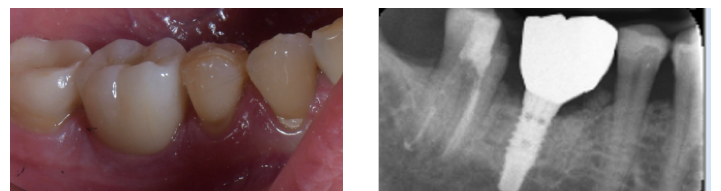
### The Outcome

After a 24-month follow-up, X-rays showed good bone stability. The soft tissue around the implant was healthy, and the patient expressed high satisfaction with the restoration.
